A new perspective towards failure of gamma nail systems

Abstract. Uncommon causes of nail failures and surgical reinterventions were determined. The study included 23 osteoporotic patients, 13 of whom followed a fast recovery program with early walking (FWB group). The other 10 patients were not allowed full weight bearing until 6 weeks (NFWB group). The T-score was determined before surgery for all cases. A case with a nail breakage after a failed DCS implant fixed in another clinic was also analyzed. The nail was revised and the broken implant underwent a metallurgic and microscopic examination. The average T-score was 2.5 for the patients that followed the fast recovery program and 2.7 for the patients from non-full weight bearing. Four patients, 1 from the NFWB group and 3 from FWB group, presented a screw cut-out. It was found that the errors of the guiding instruments may create dents, scratches or micro-fractures on the titanium coating that lead to an early implant failure. Imperfect reduction leads to incorrect implant placement and a high incidence of failure. Damaging the titanium protective coating, in a low force, high cycles scenario can cause structural failure. Del

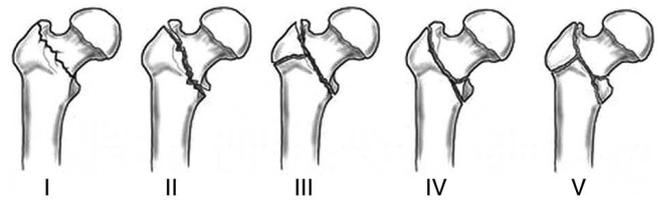
Figure 1. Evans Classification. Type I, undisplaced 2 parts. Type II, displaced 2 parts fracture. Type III, displaced 3 parts fracture with greater trochanteric comminution. Type IV, displaced 3 parts fracture with postero-medial comminution. Type V, displaced 4 parts fracture involving both trochanters.

Although there are several classifications used for this anatomical region based on various factors, the most common are those based on the fracture path (7,8) and the degree of comminution. In this study, we used the Evans Classification, which is divided into five types, starting with the first one (non-displaced with 2 fragments) and ending with the V degree, where comminution is high (Fig. 1) (9). The classifications of pertrochanteric fractures, like all classifications, have their limitations regarding reproducibility. The main challenge is to achieve a satisfactory reduction, before surgery, under C-Arm X-rays.

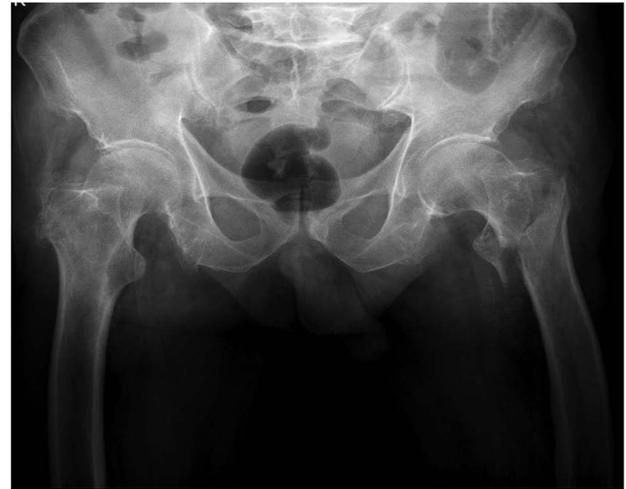
Figure 2. Rx image with left pertrochanteric fracture.

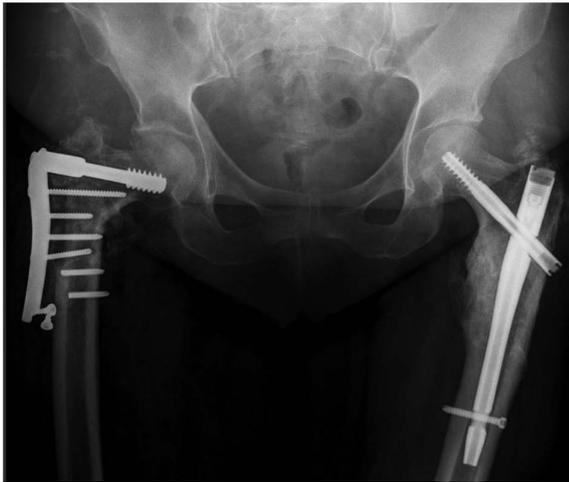
Figure 3. Before right hip surgery.

The second aspect of this study is represented by a patient with bilateral hip fractures (~2 years distance between fractures), operated in another emergency clinic with a DCS system. We changed the implant with an intramedullary nail. The right hip is of interest for this research. We applied the

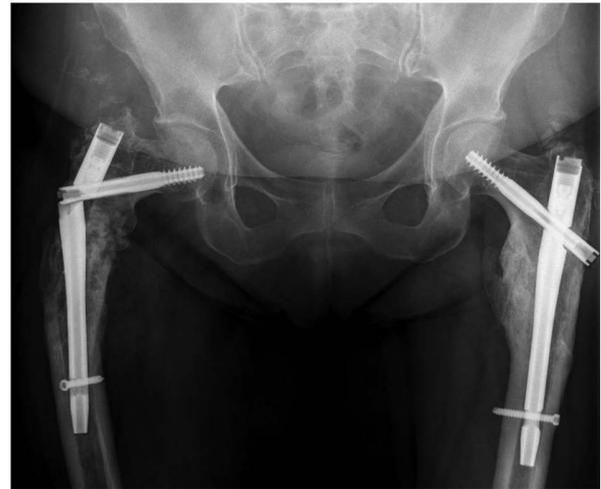
Figure 4. Approximately 6 months after right hip second surgery. Bone tunnel from the previous DCS screw is noticeable.

same method, but this time the nail broke after 6 months. The screw position was optimal. The insufficient restore of lateral femoral cortical bone was identified as the cause. The stress shielding forces were high and the bone healing was incomplete. The nail broke in the proximal part. A good solution was bone grafting and a longer nail. The same screw position was used the second time. Pain levels were low and the patient was able to walk. No follow-up was possible (Figs. 3 and 4). No sign of infection was identified. There were no skin complications and the bacterial cultures were negative.

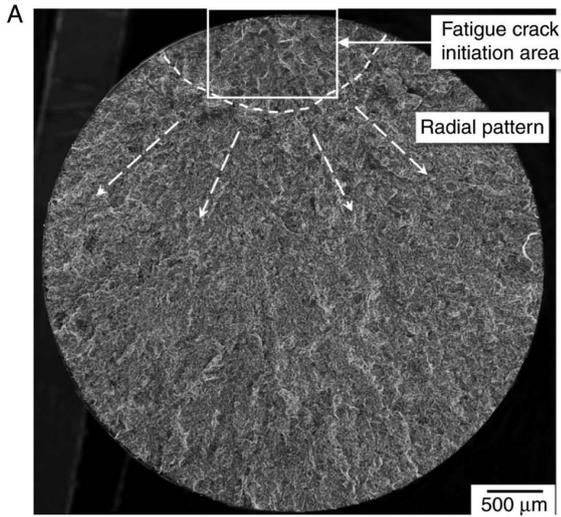
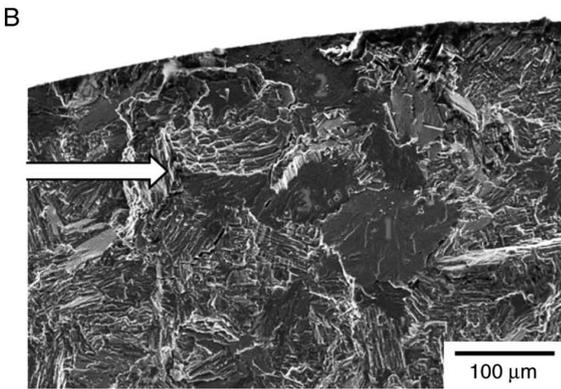
The proximal part of the broken nail was sent for analysis. Metallurgic tests and scanning with an electronic microscope were performed. Fatigue zones were identified at the contact between the nail and the screw. It is well-known that most of the fatigue cracks initiate at free surface. This phenomenon occurs only in special cases when a very high cycles fatigue test is performed (Fig. 5A and B) (16).

This type of changes in the structure were not confirmed at low-cycle or high-cycle fatigue tests for TIA16V4 (17). We suspected that nonunion of the fracture was not the only cause of breakage. High tolerances of the lag screw guide (from

Figure 5. (A) Fatigue crack (modified). (B) Fatigue cracks initiation area (modified)-low stress. 1-4-titanium material crack initiation.

This finding led us to further investigate the broken implant, after extraction. On a microscopic view, we observed small cracks and dents produced by the lag screw in the hole of the nail. Titanium is an extremely stiff material, resilient to bending. It tends to increase stress shielding on fracture level. Small scratches in the weakest point of the nail can determine a decrease in resistance. In this particular case, this was the second surgery, so bone healing was slower. Could small errors in the guiding system cause a decrease of the nail resistance? We identified up to 1.4 mm of error in the system guiding instruments tray, caused by multiple use and perhaps also being inadequate (Fig. 8).

In our study and after a thorough review of major publications, we have identified a novel factor of gamma nail failure. Breakage of the nail at the lag-screw level can be determined by errors in the guiding instruments. These high tolerances can cause dents or scratches in the protective titanium coating. This can lead to early implant breakage due to stress forces in a high-cycles environment. Extra care should be promoted to fracture reduction and adequate use of the gamma instruments tray. It is obvious that the forces exerted at this level do not meet the critical level of implant breaking point, but after a high number of cycles with a lower stress level, the lifetime and resistance of titanium alloy components are greatly reduced. This theory was also observed in other modular systems, used in the orthopedic field.

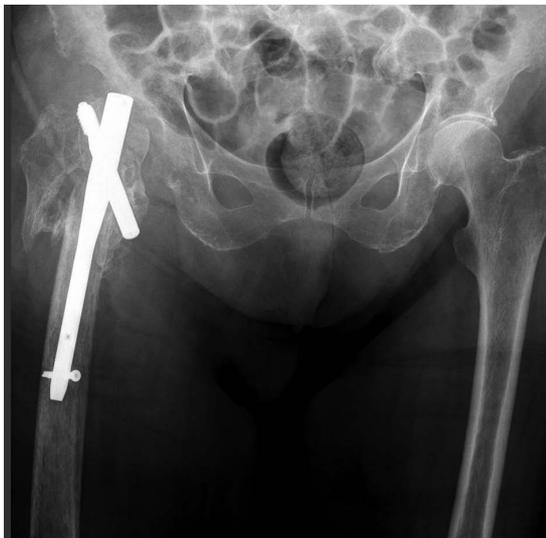
Figure 6. Eighty-three-year old patient, operated in another hospital, presented at our emergency room with local sepsis signs and major misplacement of the implant.

The last case was an extremely misplaced implant with associated severe sepsis and non-union (Figs. 6 and 7). In this particular case, there was a drastic error in the reduction of the fracture, associated with life threatening comorbidities.

The next case that we analyzed was a failed gamma nail due to multiple causes. When including this case in the study, we wanted to advocate the fast reintervention for this type of patients. An 83-year old diabetic patient presented to our emergency room with clinical sepsis, with a malpositioned nail, without fracture reduction, 8 months after surgery in another hospital. She did not address another hospital services and no follow-up information was available during this period of time. Septic signs appeared one month before presenting to our clinic (family anamnesis, patient had a semicomatose

status). At the clinical exam, we identified a right shoulder arthritis. Since the patient's status was rapidly declining, we decided to perform extraction of the implant and debridement (Fig. 9). Unfortunately, during surgery, the patient went into septic shock.

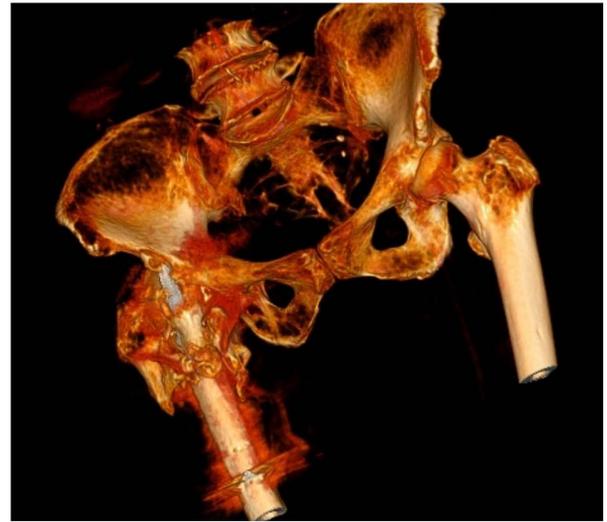
Figure 7. 3D CT reconstruction of the 83-year old patient.

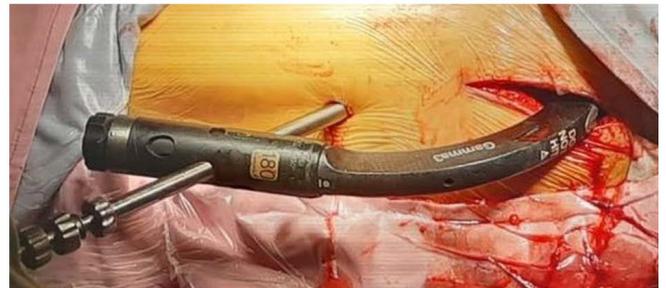
Figure 8. Nail guiding system.

Checking the guide for the lag screw, we identified an average of 1.4 mm error, from 10 tests. The cause for this

error was the locking hex screw that locks the guide to the nail and also the threaded kirschner wire, used as a guide. That allows small errors at the passing of the drill through the nail. Small scratches on the coating and inside the nail's hole were observed.

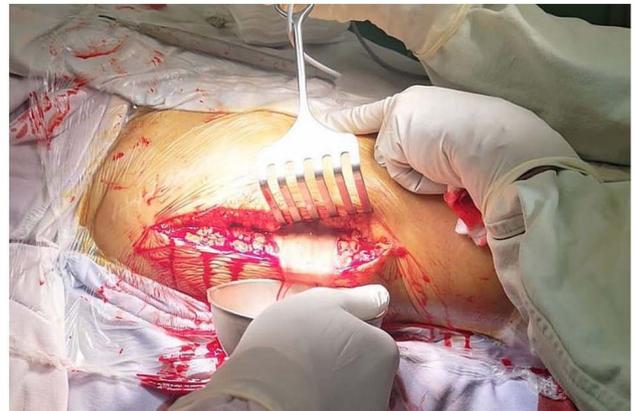
An 83 years old patient, female, with diabetes, represents the third part of this report. She presented at the emergency room with pain. Weight bearing was impossible. She had a pertrochanteric fracture operated a year before in another service. The implant was compromised with no signs of callus. Blood sugar levels were uncontrolled and at the clinical exam, we identified multiple sacral sores. Clinical signs of shoulder arthritis were present. The affected thigh was 12 cm larger in diameter, hot and associated with redness. We decided to perform surgery and drainage. The following day, the patient was in a semicomatose state. During surgery, an extremely large quantity of pus was extracted.

Figure 9. High quantity of pus in the hip region.
